Vibration-Induced Fatigue – A Risk-Based Approach

Michael Cyca, MSc, PEng

Wood Group
Vibration, Dynamics & Noise

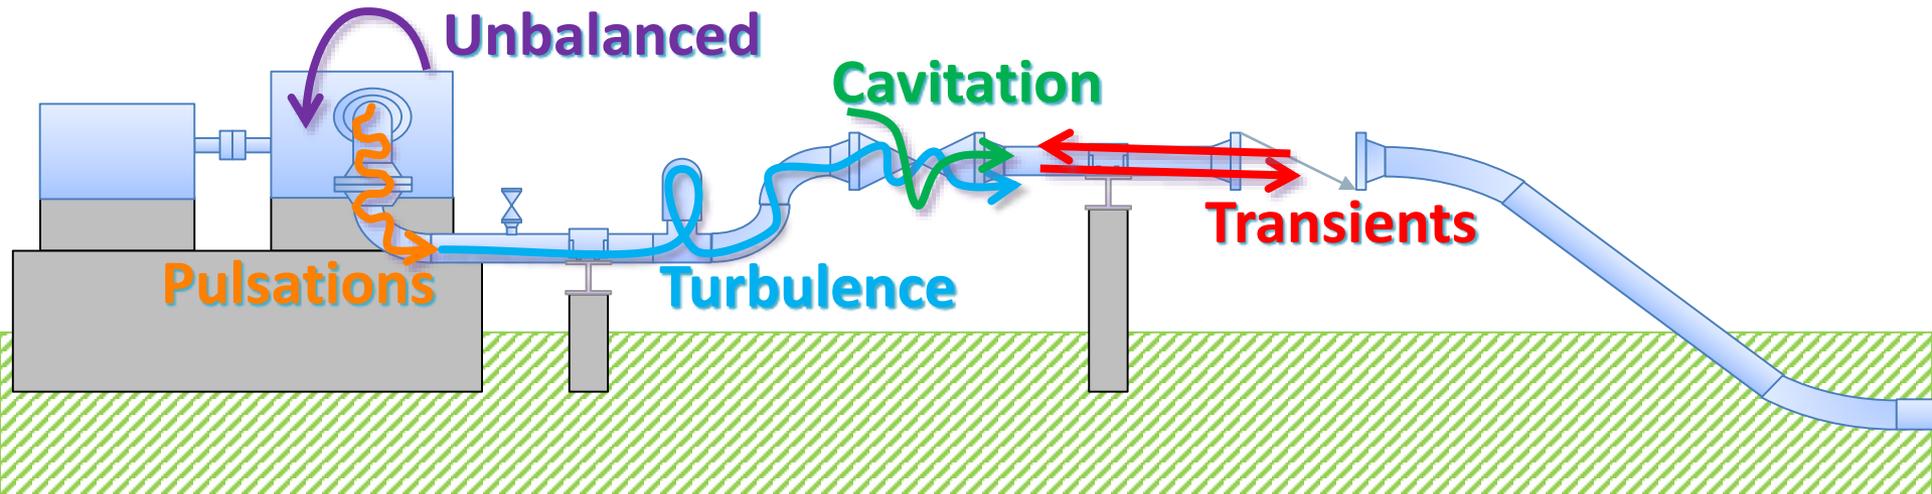
Vibration Excitation Mechanisms

- Machinery excitation
- Pressure pulsation
- Turbulence
- Flashing/cavitation
- Transients (water hammer)
- Rotating stall
- Dead-leg pulsation
- Acoustic-induced

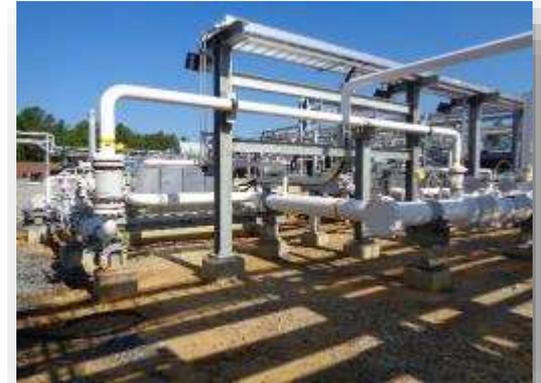
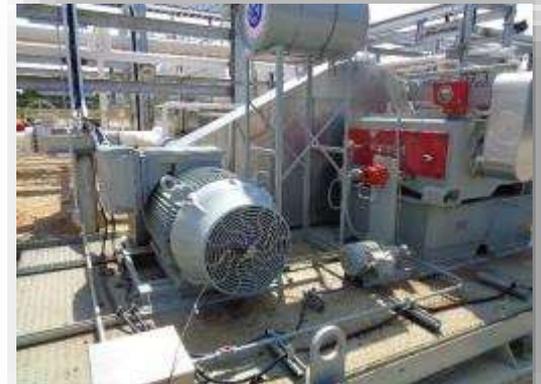
Case Study #1 – Plunger Pump

Description:

- Quintuplex Plunger Pumps @ 297 HP
- Liquid Propane
- Speed Range 200-400 RPM
- 6 months in operation
- **Very high piping vibrations!**

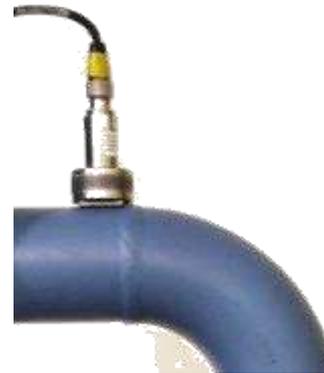
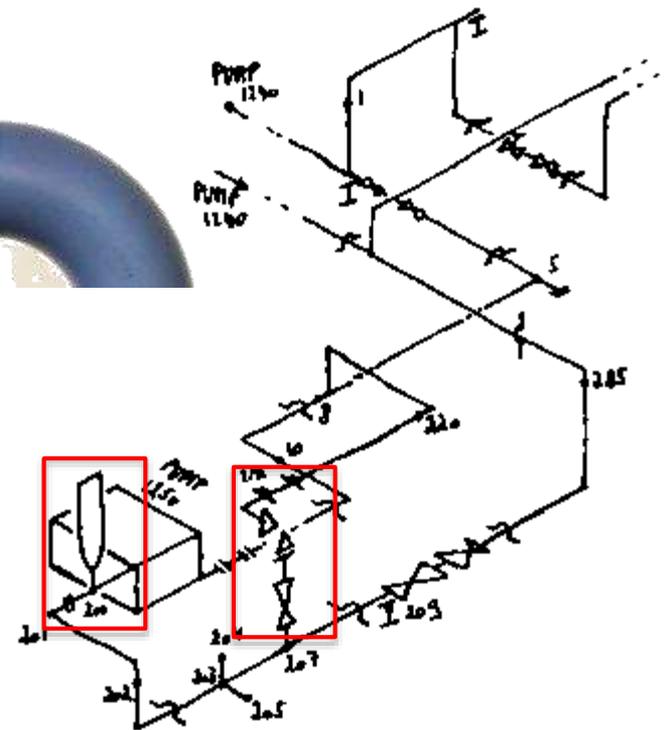
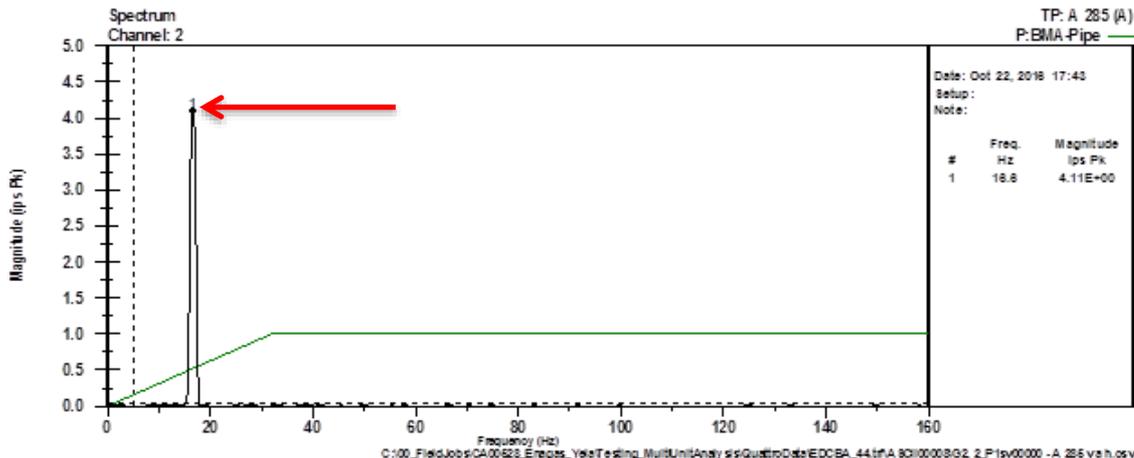
Case Study #1 – Plunger Pump

Field Visit:

- High vibrations measured
- PSV resonant
- Dampener resonant

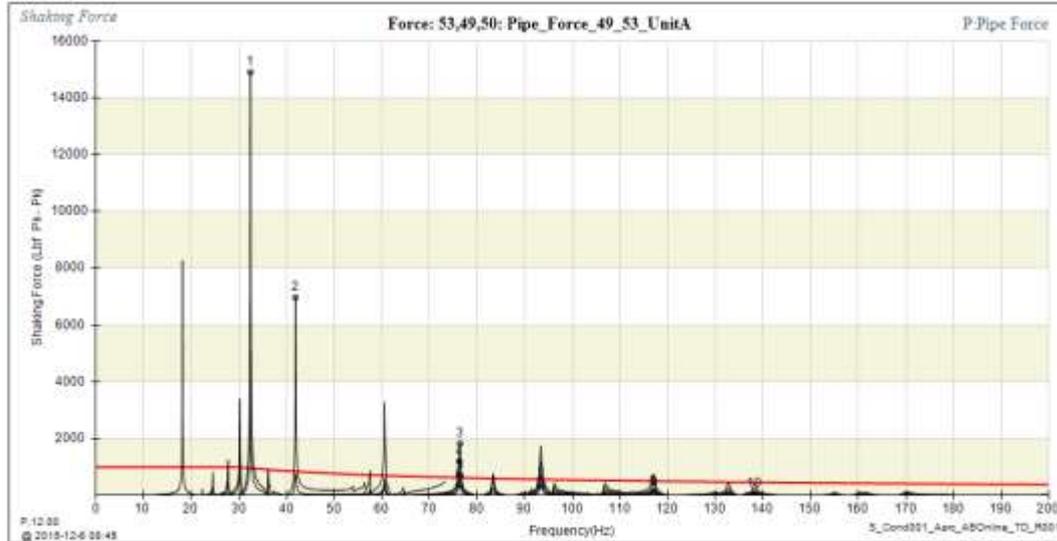
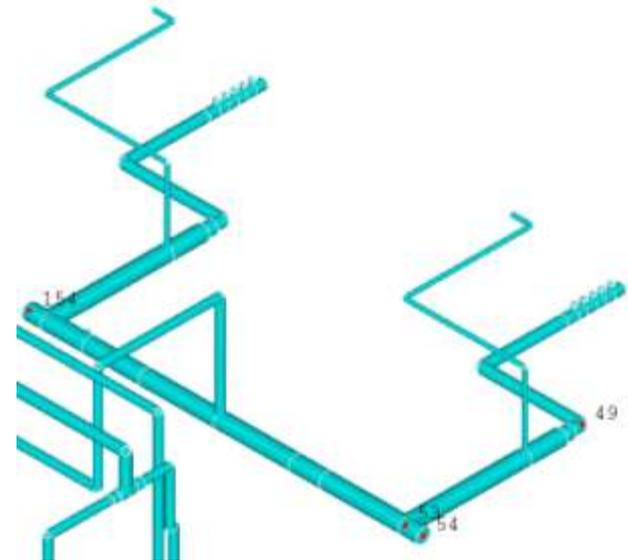
Case Study #1 – Plunger Pump

Vibration analysis (API 674):

- System modelled using proprietary software
- Very high shaking forces predicted
- Due to pressure pulsations

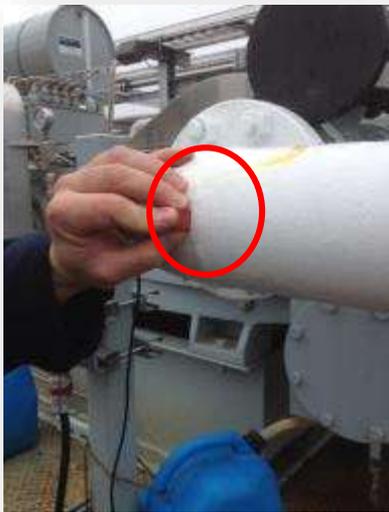
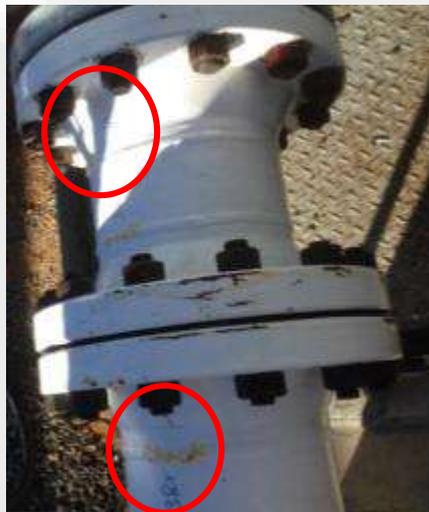
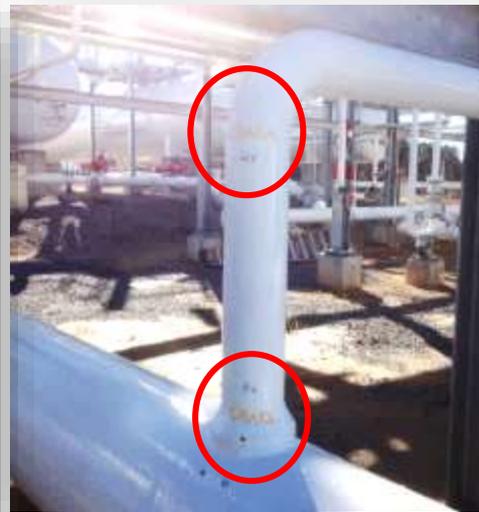
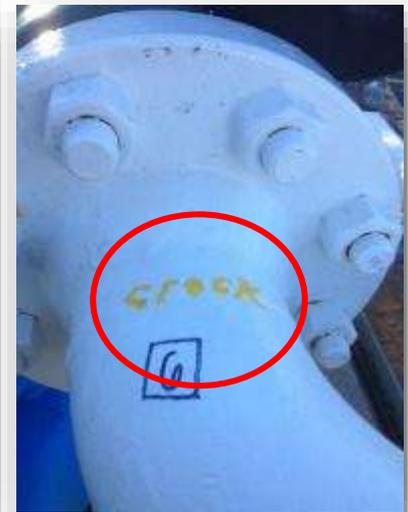
Case Study #1 – Plunger Pump

Field follow-up:

- NDT locations determined from highest predicted forces
- Significant cracking found
- Units shutdown

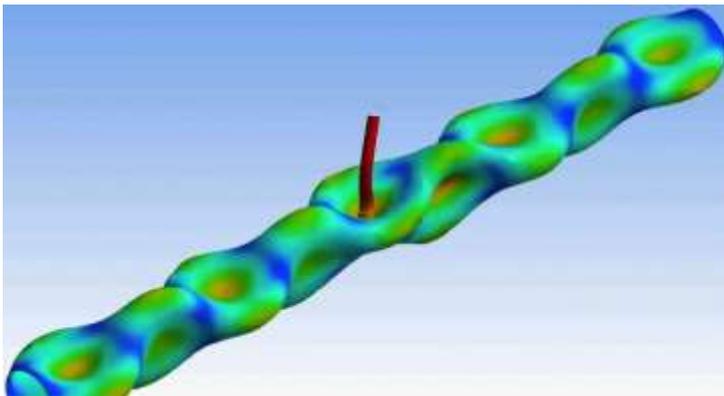
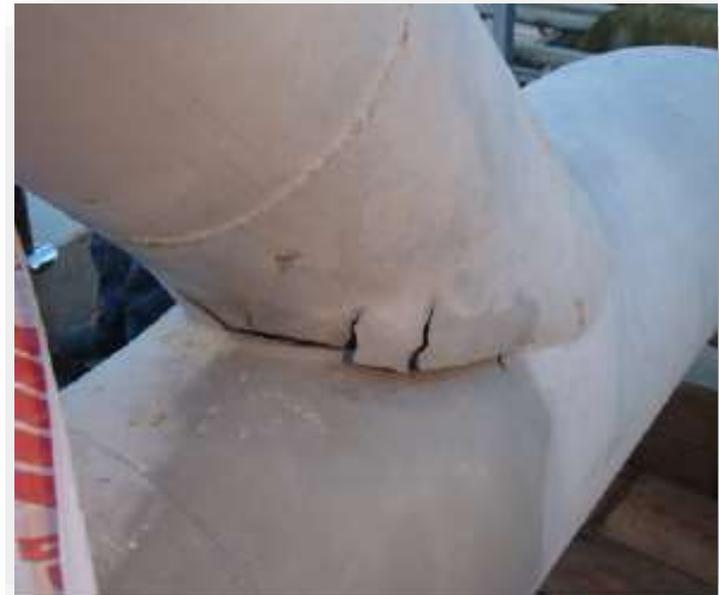
Case Study #2 – Acoustic-Induced Fatigue

Description:

- At pressure letdown (eg, control valve, blowdown, PSVs)
- Flare systems (API 521)
- Not visible, but frequently audible
- Short time to failure
- Failures at branches, supports, etc

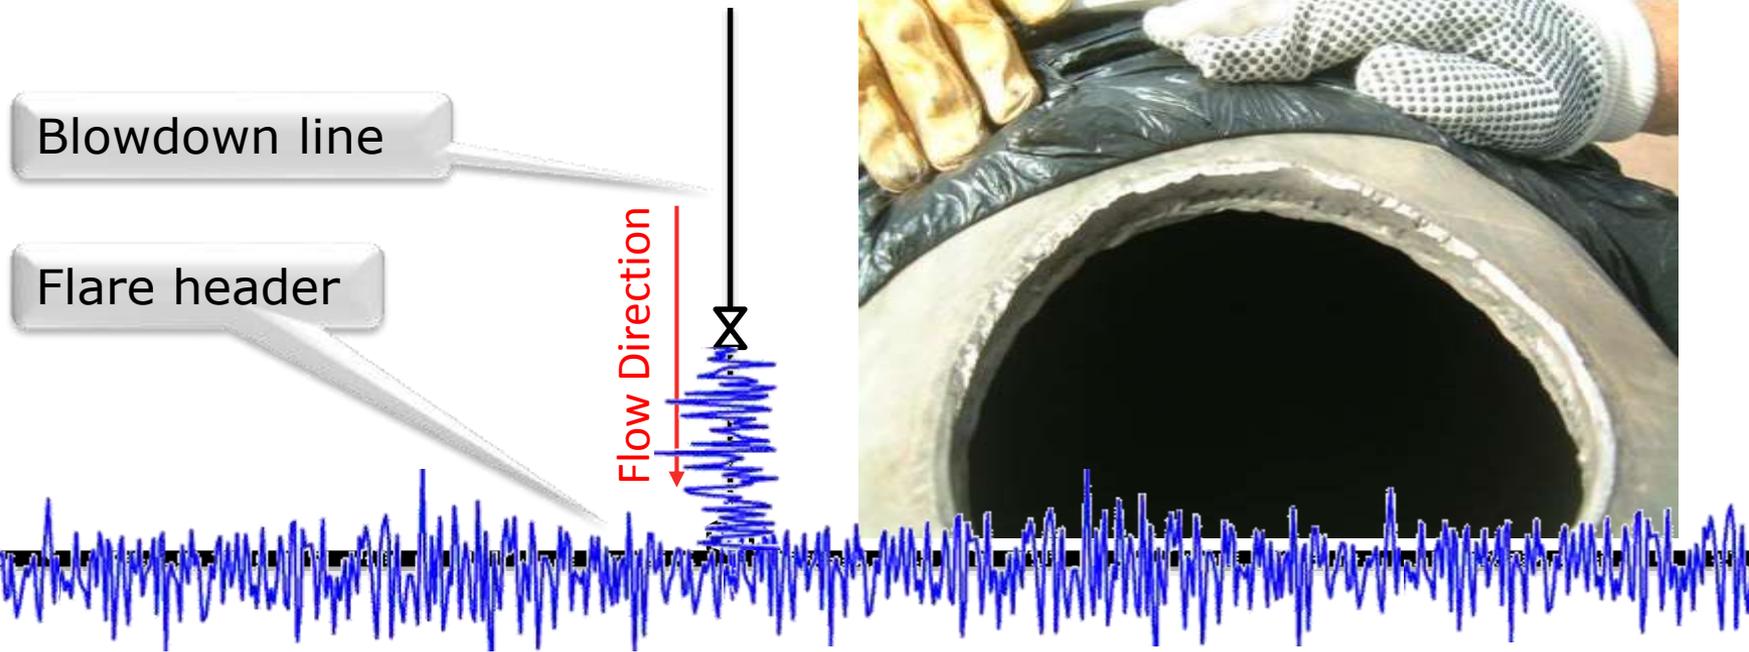
Case Study #2 – Acoustic-Induced Fatigue

- Catastrophic failure
- 6” blowdown line to 16” flare header
- Desktop screening would have flagged the connection as a concern

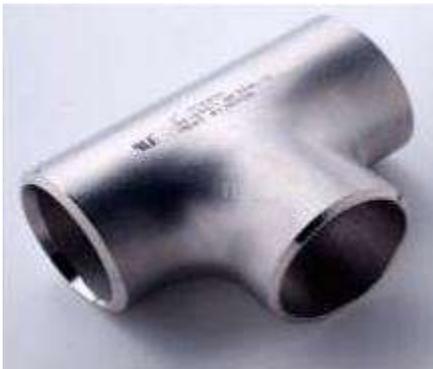
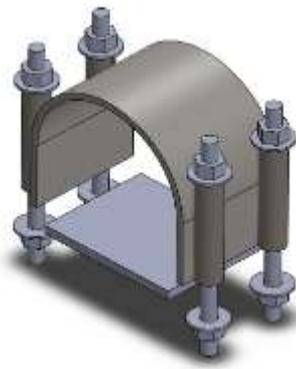
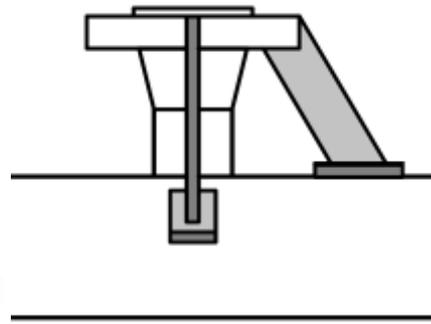
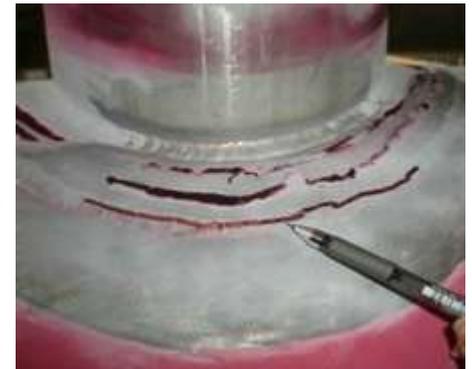
Case Study #2 – Acoustic-Induced Fatigue

Recommendations:

- Conduct screening of pressure-relief systems (API 521)
- Use forged tees instead of fabricated tees
- Change from welded to bolted supports
- Reinforce branch connections, where necessary
- Target NDT at high-risk branch connections

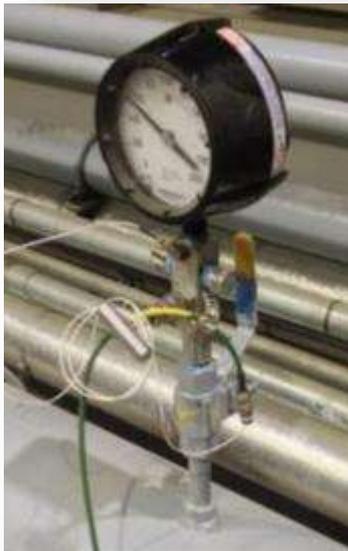
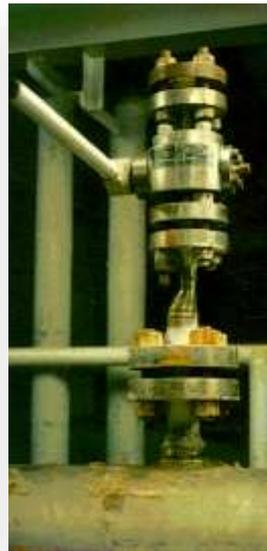
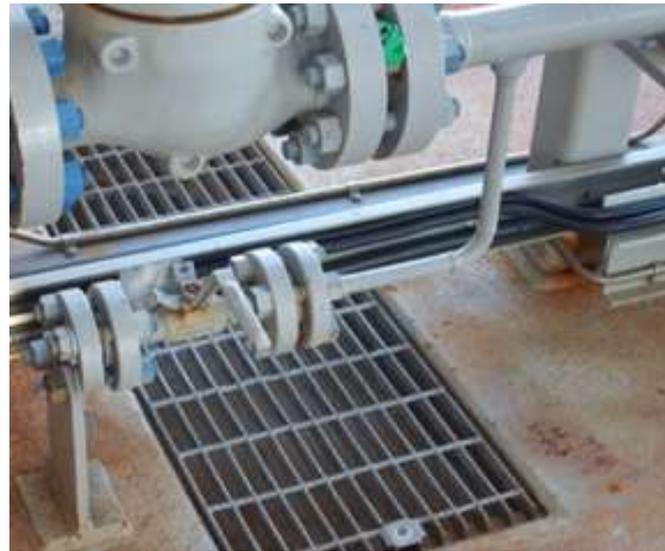
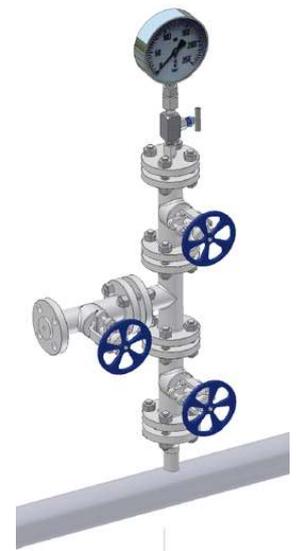
Small-Bore Connections

Description:

- Problematic in vibrating service
- Should be removed, moved, redesigned or braced

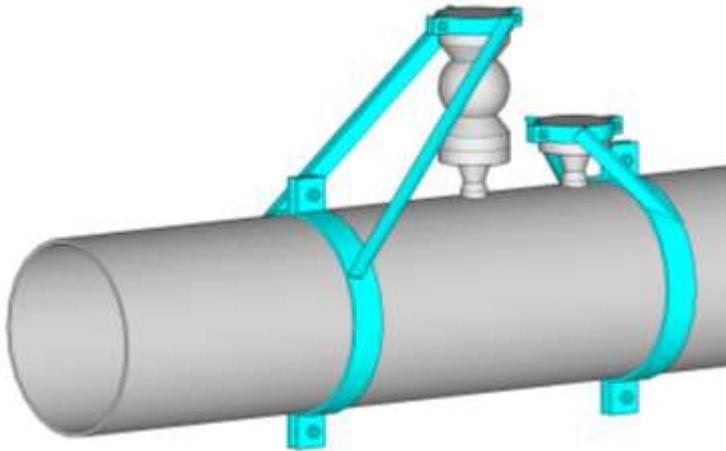
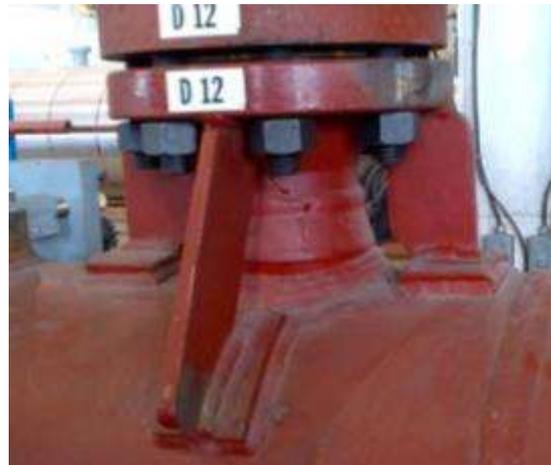
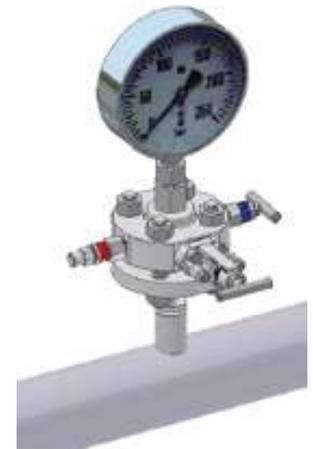
Small-Bore Connections

Recommendations:

1. Avoid redundant connections (or remove them)
2. Reduce length and mass
3. Brace back to the vessel or pipe (not to anything else!)
4. Use Schedule 160 pipe for nipples
5. Use monoflange valves, or similar

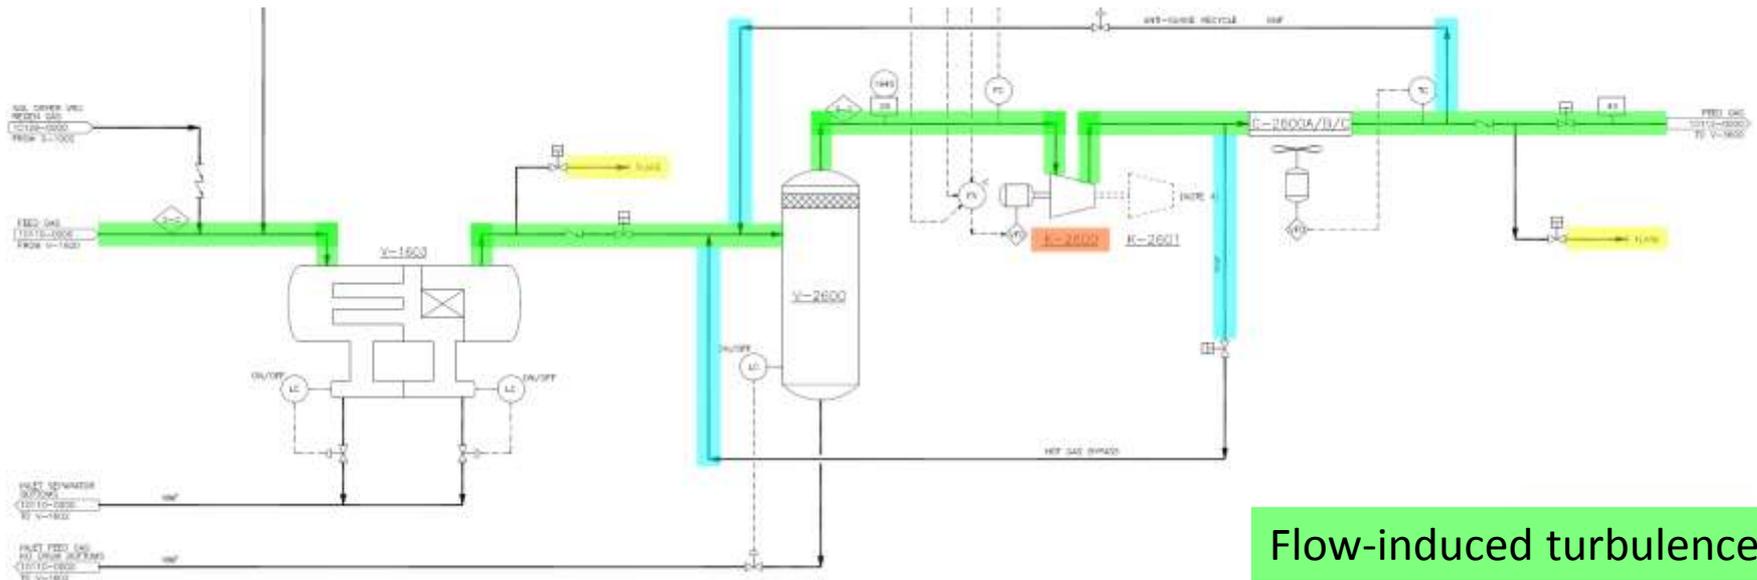
Marked-up PFDs/P&IDs

Flow-induced turbulence

Mechanical excitation

Dead-leg pulsation

Acoustic-induced vibration
